Manhole Inspection Summary

Manhole # S25CC_052MH

Inspection ☐ Is Incomplete Rating: **3) Fair**

Location Address: **1125 CARROLTON-CARLTONN**

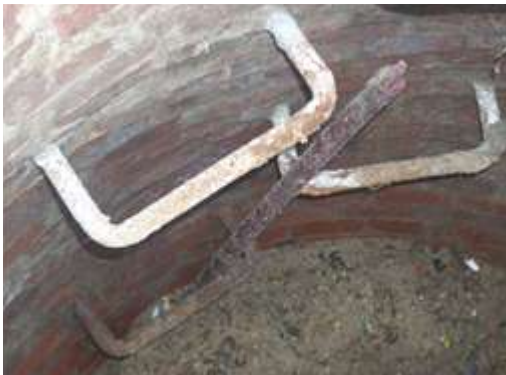
Defect 3

Steps Count: **4** Missing: **0** ☒ **Corroded**

corroded steps

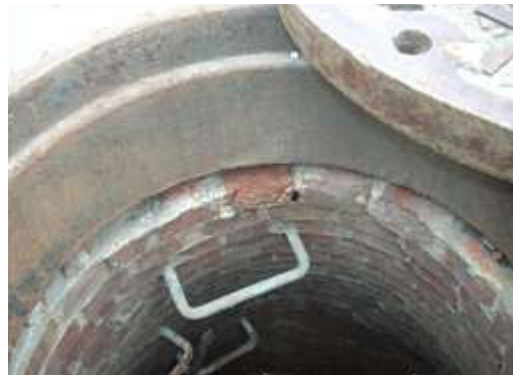
Defect 2

Condition: ☐ Sound ☐ Cracked ☐ Root Intrusion ☐ Loose Brick ☒ **Deteriorated**

deteriorated corbel

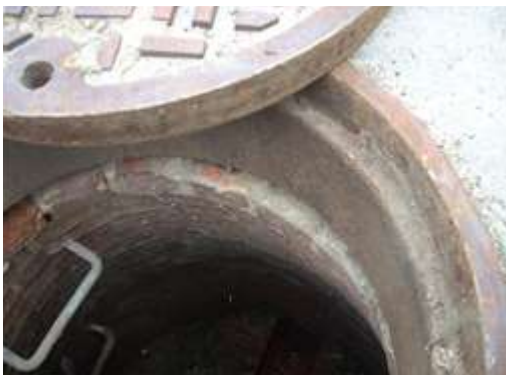
Defect 1

Frame Offset: **2** (in.) Condition: ☒ Sound ☐ Cracked ☐ Leaks

frame offset

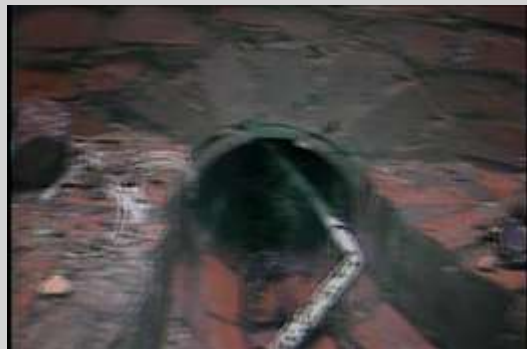
9 O'Clock Inflow

Deposits: ☐ None ☐ Mud ☐ Sludge ☒ **Debris** ☐ Grease

Silt Depth: **1** (in.) Deposits Extent: **Light**
